# TEST REPORT

## PF25014

### Fire resistance test for penetration through a vertical separating element

| Client: | BOSS Products (Australia) Pty Ltd |

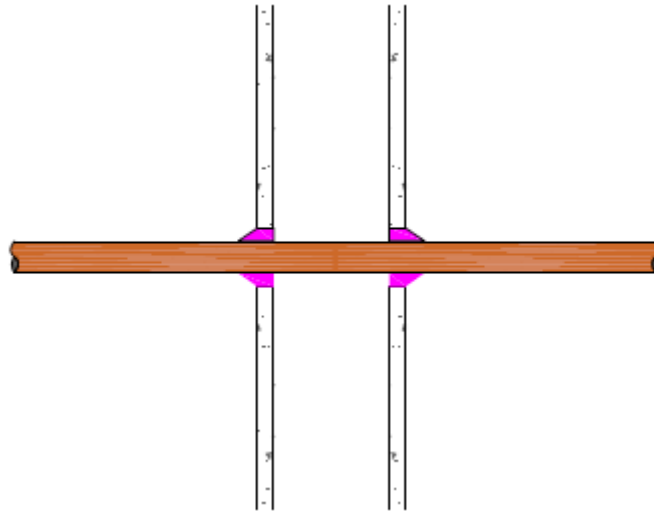
Figure 4 - Specimen 1

| Time min | Test face | SP# | OBSERVATIONS/REMARKS |
|---|---|---|---|
| 4 | E | 1 | Pipe dislodged from the separating element |
| 28 | U | 1 | Smoke coming through from around the pipe |
| 52 | U | 1 | Hole in pipe, intumescent engaged and sealant expanding |

| Integrity | No failure at 95 minutes |
| Insulation | 90 minutes |

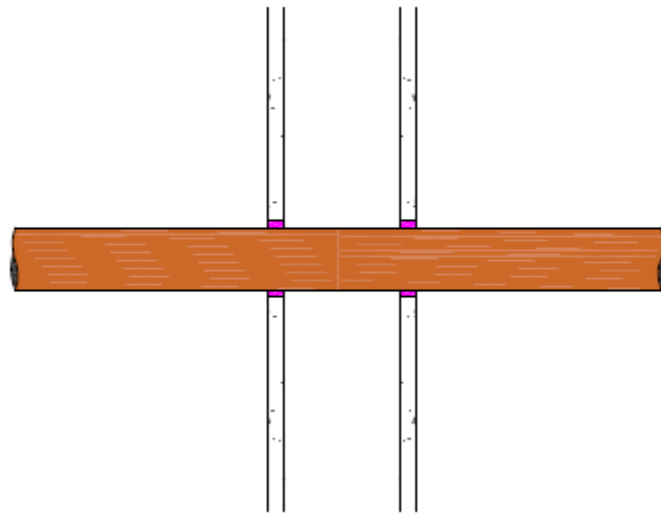
Figure 6 - Specimen 2

| Time min | Test face | SP# | OBSERVATIONS/REMARKS |
|---|---|---|---|
| 18 | U | 2 | Sealant visibly starting to discolour |
| 25 | U | 2 | Discolouration visible on pipe |

| Integrity | No failure at 95 minutes |
| Insulation | 11 minutes |

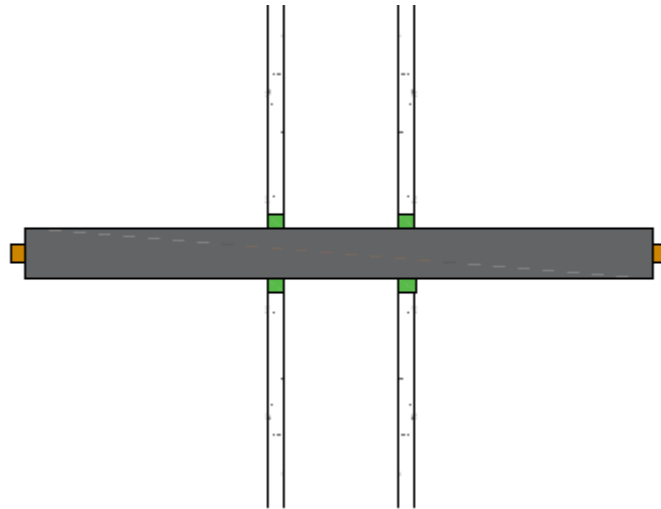
Figure 8 - Specimen 3

| Integrity | No failure at 95 minutes |
| Insulation | 88 minutes |

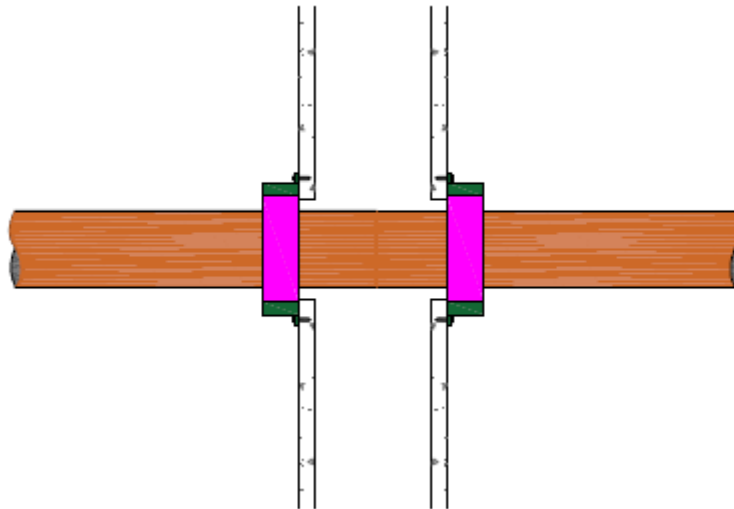
Figure 10 - Specimen 4

| Time min | Test face | SP# | OBSERVATIONS/REMARKS |
|---|---|---|---|
| 3 | U | 4 | Smoke coming through from between the collar and separating element |
| 18 | U | 4 | Moisture and discolouration visible on the separating element around the collar |

| 83 | U | 4 | Hole developed at top of pipe, intumescent visible |
| 88 | U | 4 | Open flame + 10sec |
| 91 | U | 4 | Pipe dislodged from the separating element |

| Integrity | 88 minutes |
| Insulation | 88 minutes |

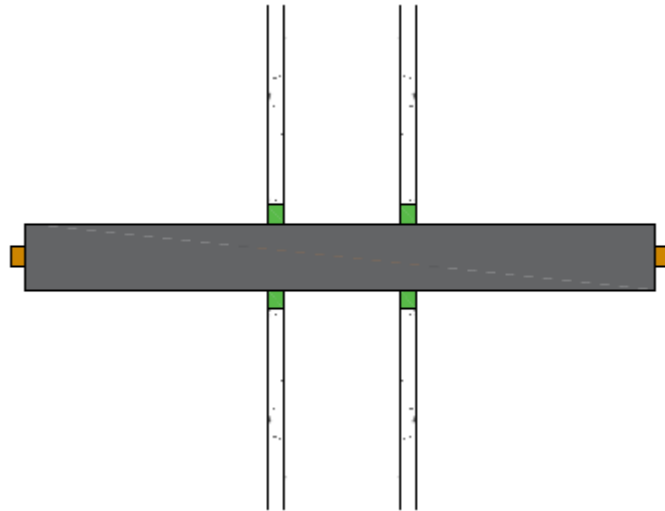
Figure 12 - Specimen 5

| Time min | Test face | SP# | OBSERVATIONS/REMARKS |
|---|---|---|---|
| 42 | U | 5 | Crack in nitrile rubber insulation, smoke coming through |

| Integrity | No failure at 95 minutes |
| Insulation | No failure at 95 minutes |

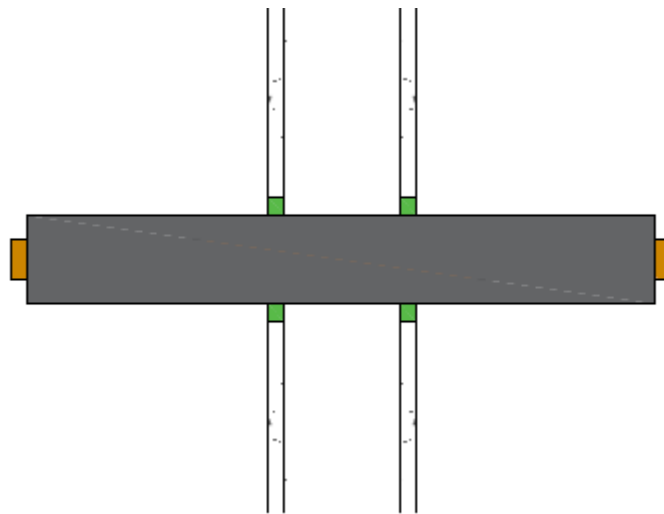
Figure 14 - Specimen 6

| Time min | Test face | SP# | OBSERVATIONS/REMARKS |
|---|---|---|---|
| 42 | U | 6 | Crack in nitrile rubber insulation, discolouration of insulation |

| 70 | U | 6 | Intumescent from sealant beginning to fall away from the separating element |

| Integrity | No failure at 95 minutes |
| Insulation | 77 minutes |

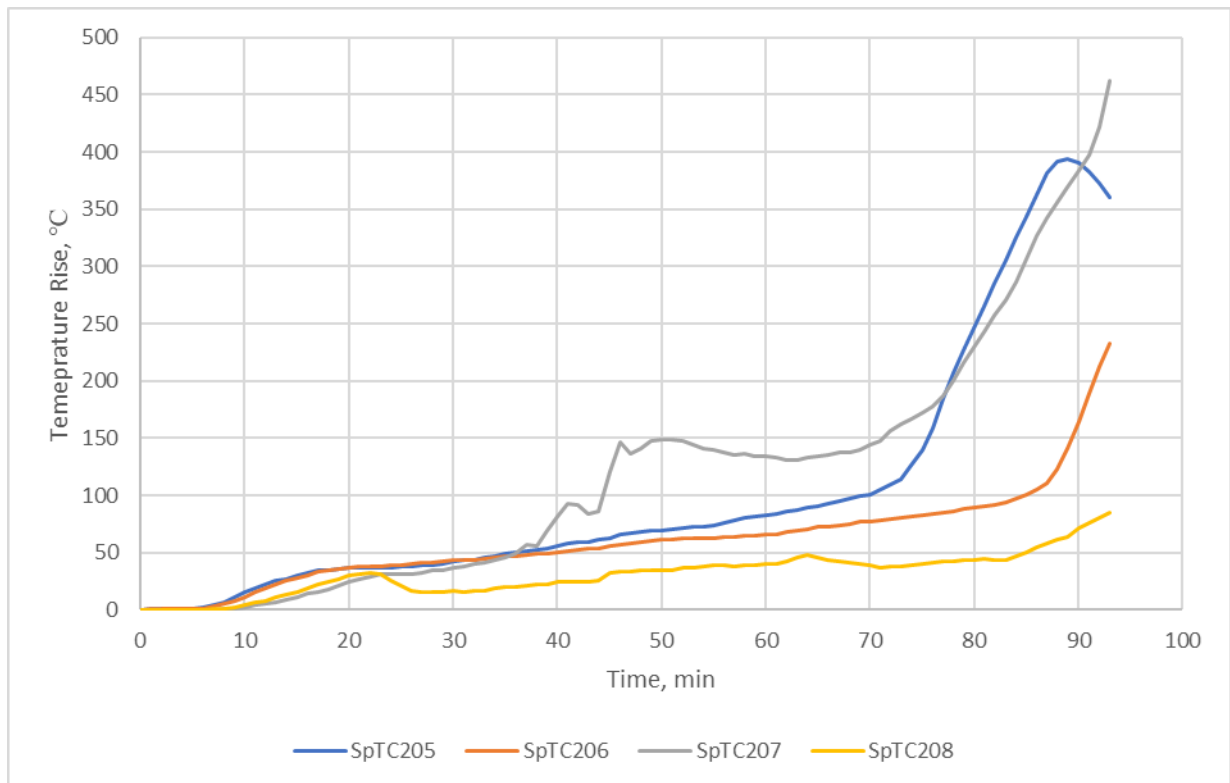
Figure 15 - Specimen 6 thermocouple temperature rise readings

- TC207 partially dislodged at 57 minutes
- TC207 became embedded and started recording the intumescent temperature at 62 minutes
- Roving thermocouple temperature measured at the top of the service at 75 minutes – 130°C
- Roving thermocouple temperature measured at the top of the service at 80 minutes – 150°C
- Roving thermocouple temperature measured at the top of the service at 85 minutes – 180°C

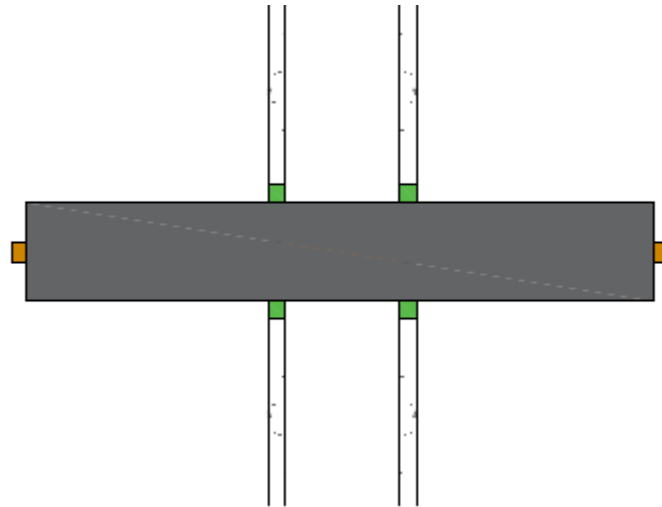
Figure 16 - Specimen 7

| Integrity | No failure at 95 minutes |
| Insulation | No failure at 95 minutes |

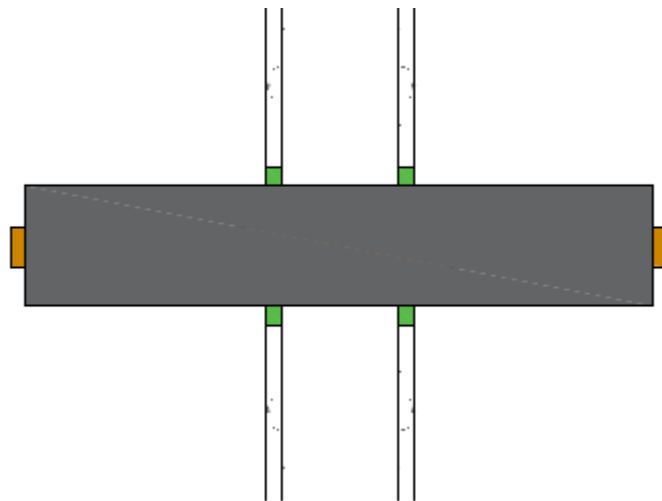
Figure 18 - Specimen 8

| Time min | Test face | SP# | OBSERVATIONS/REMARKS |
|---|---|---|---|
| 62 | U | 8 | Discolouration of nitrile rubber insulation |
| 66 | U | 8 | Crack in nitrile rubber insulation, smoke coming through crack |

| Integrity | No failure at 95 minutes |
| Insulation | 90 minutes |

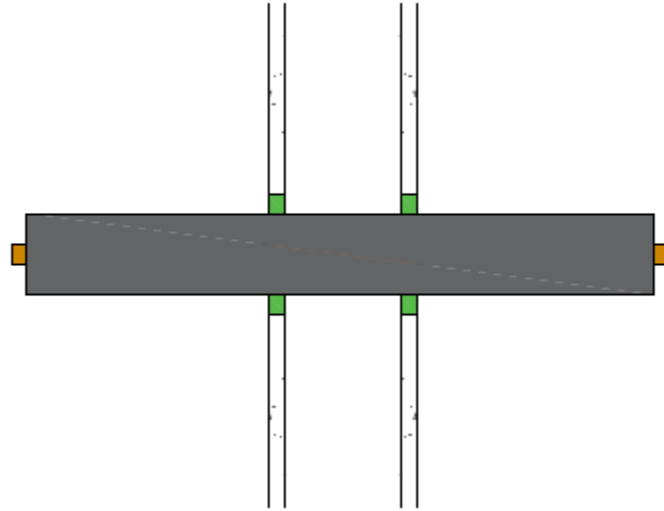
Figure 20 - Specimen 9

| Integrity | No failure at 95 minutes |
| Insulation | No failure at 95 minutes |
