## **Test report # PF23030**

**Client: BOSS Products (Australia) Pty Ltd**

**Fire resistance test for penetrations through  
vertical separating element**

**Test method: AS 1530.4:2014**

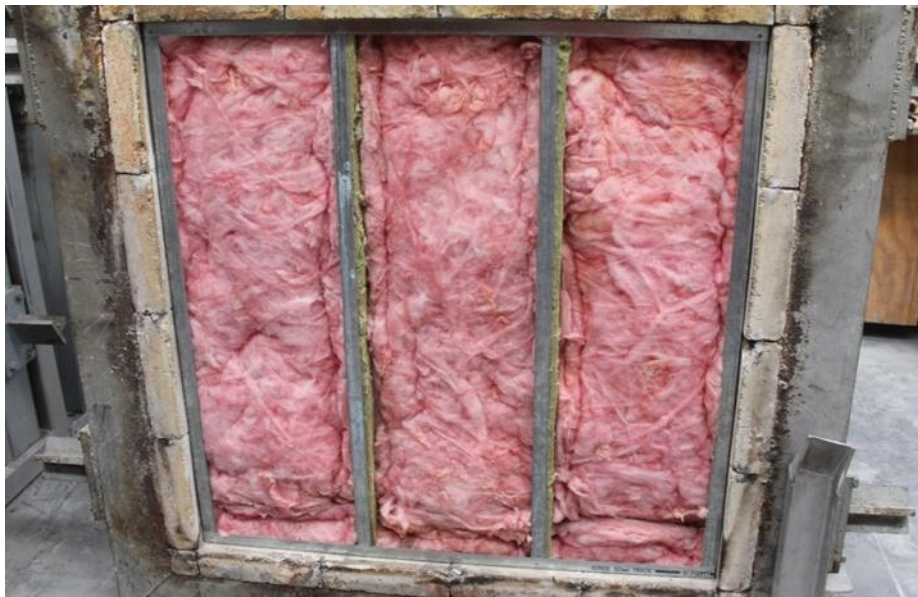
The separating element was constructed in line with the general requirements of the GBS60 system of GIB Fire Rated Systems – Specification and installation manual (Oct 2018) with modification to the studs and nogs in terms of spacing and introduction of mineral wool inserts. Separating element consisted of 92x36mm 0.75mm BMT steel framing. Cavities were isolated from each other with 50mm thick Boss Fire batt. The wall was insulated with R1.8 90mm thick glasswool insulation.

**Figure 6 – Separating element framing**

One layer of 13mm fire rated plasterboard was fixed on both sides of the framing. The plasterboard was screw fixed to each face of the separating element. Apertures were cut to size, refer to specimens' description.

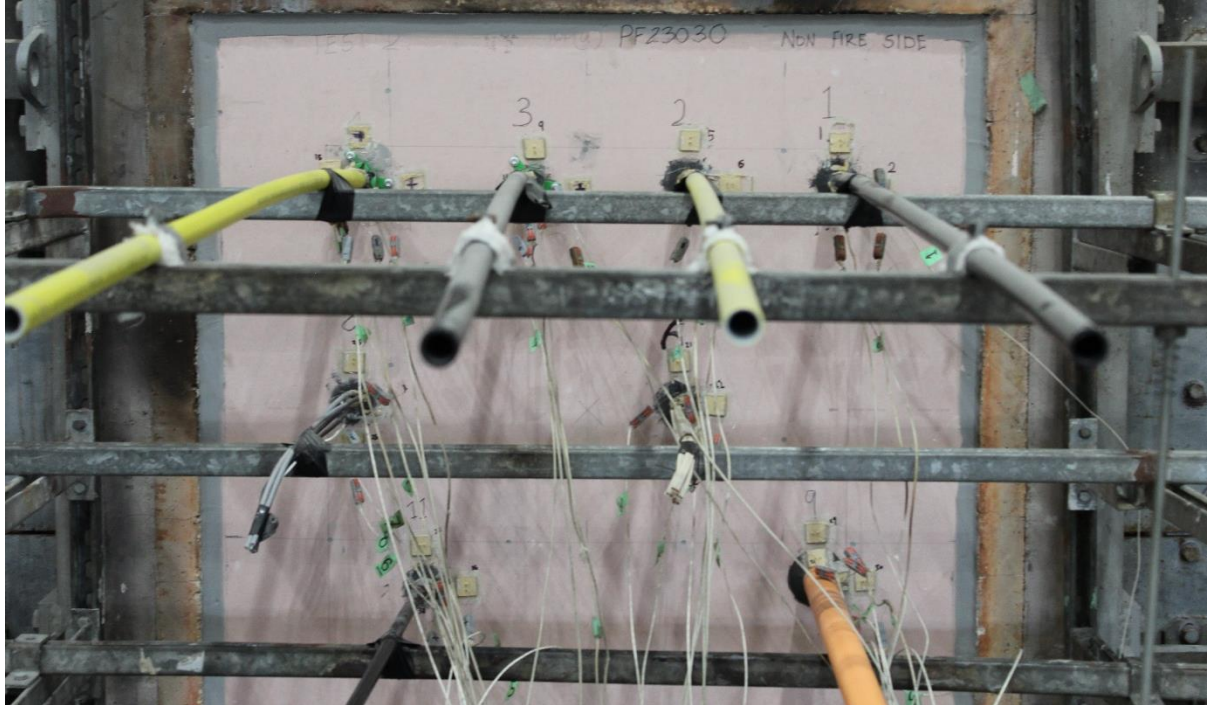
**Figure 7 – Unexposed Face of Specimens**

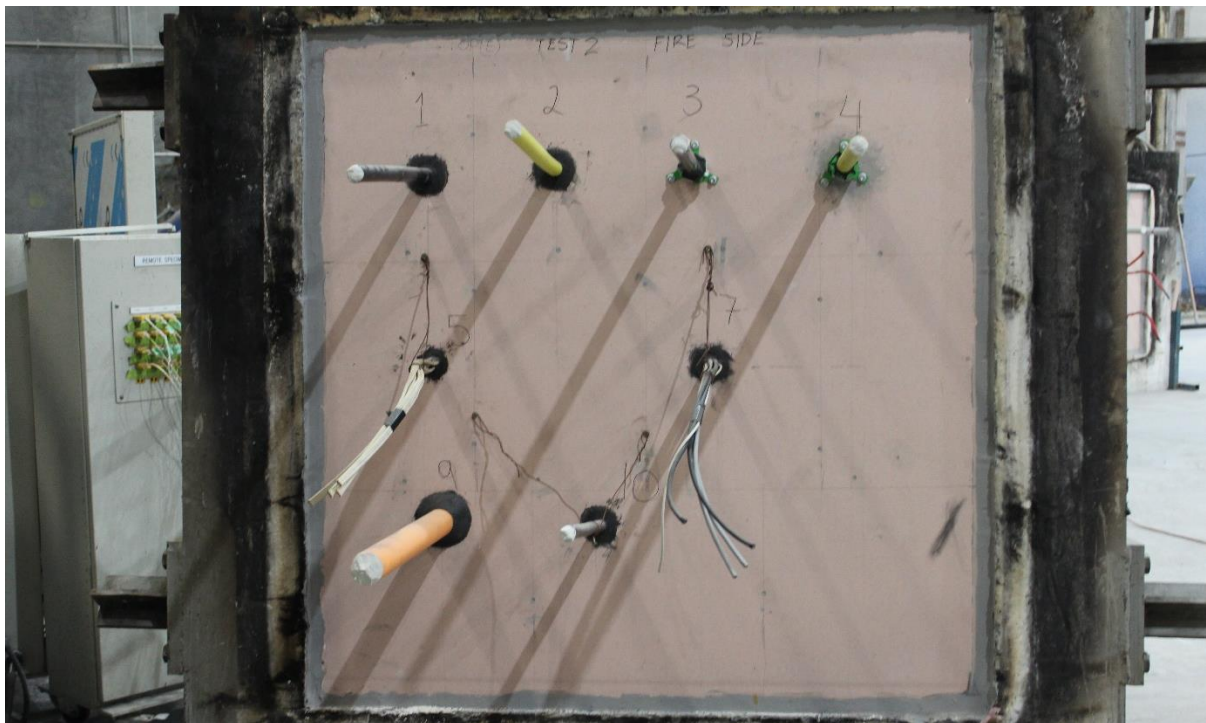
**Figure 8 – Exposed Face of Specimens**

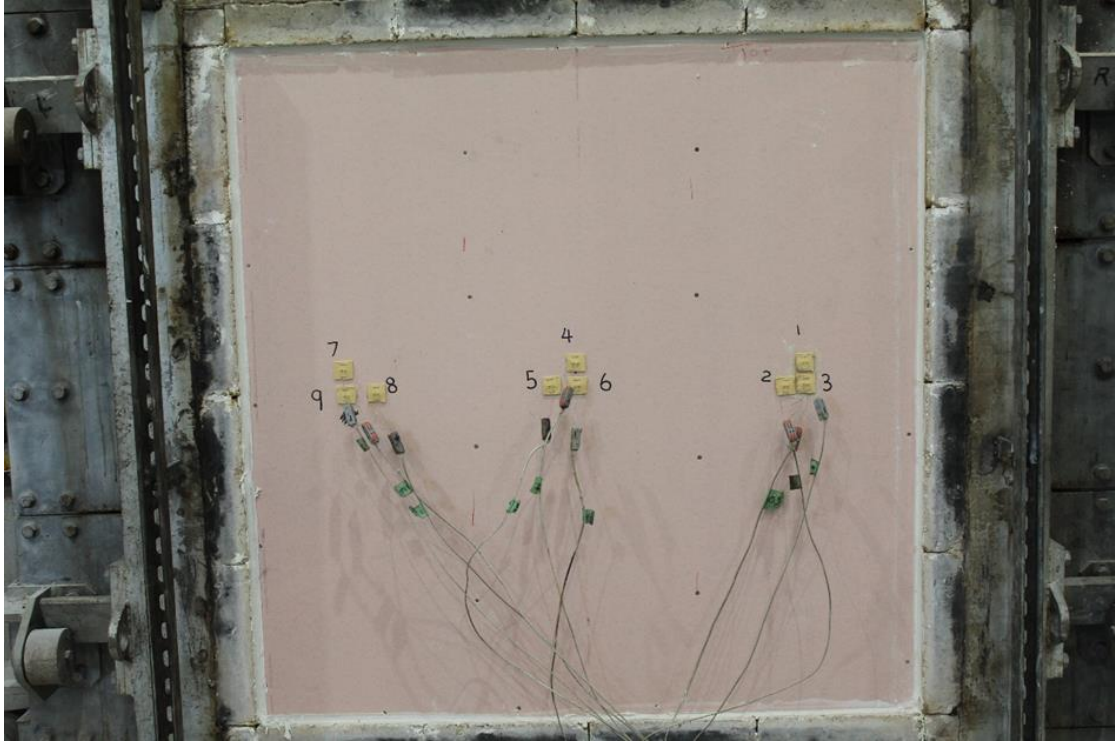
**Figure 25 – Unexposed Face of Specimens**
