# TEST REPORT

## PF25012

### Fire resistance test for penetration through a vertical separating element

| Client: | BOSS Products (Australia) Pty Ltd |

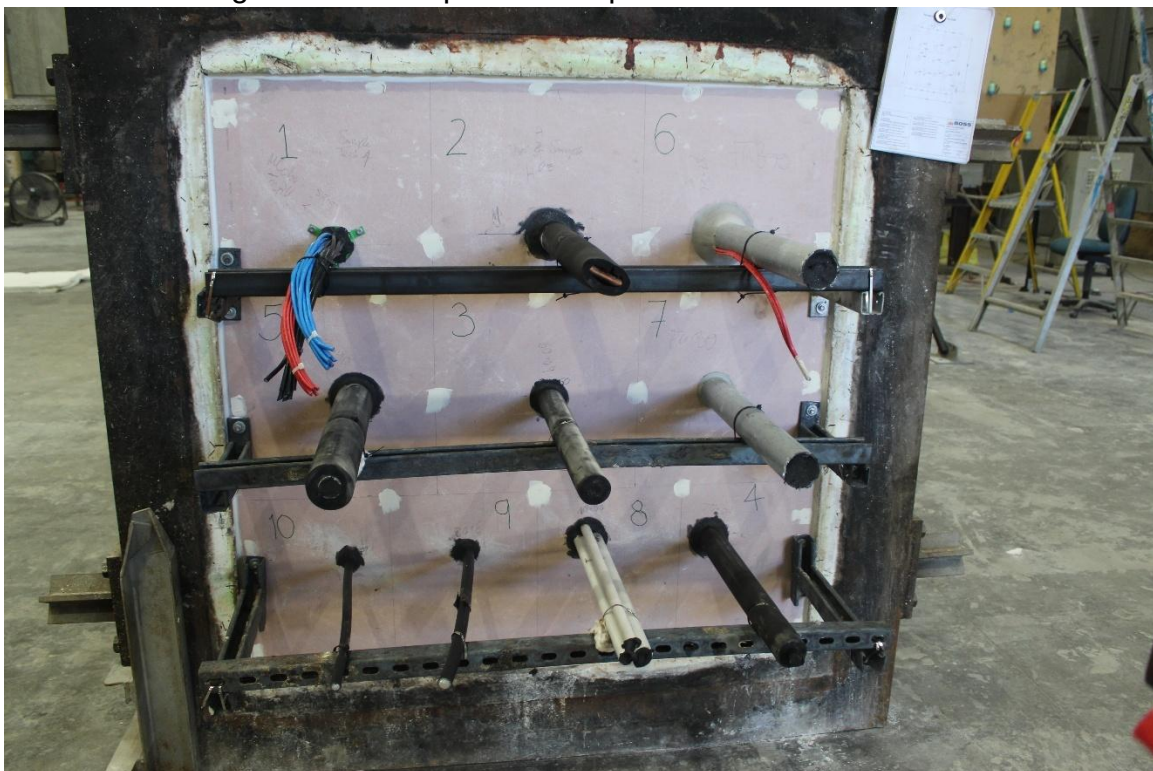
Figure 25 - Exposed face prior to test commencement

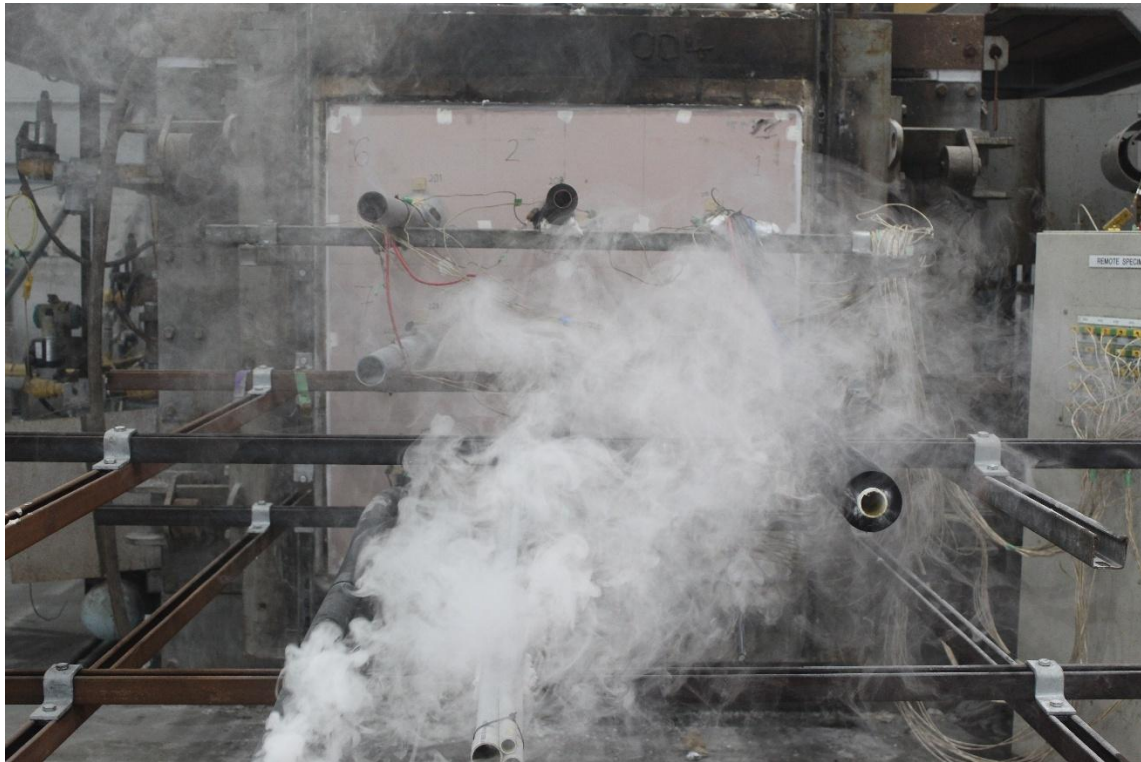
Figure 26 - Unexposed face at 15 minutes

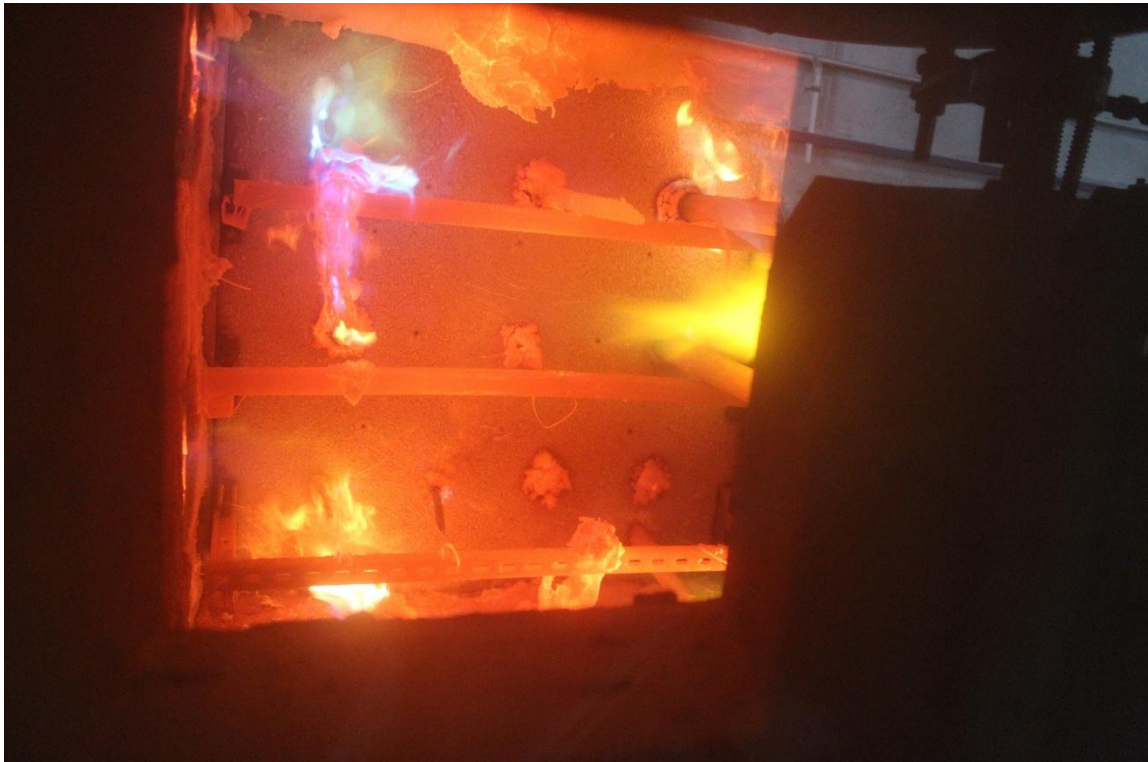
Figure 27 - Exposed face at 15 minutes

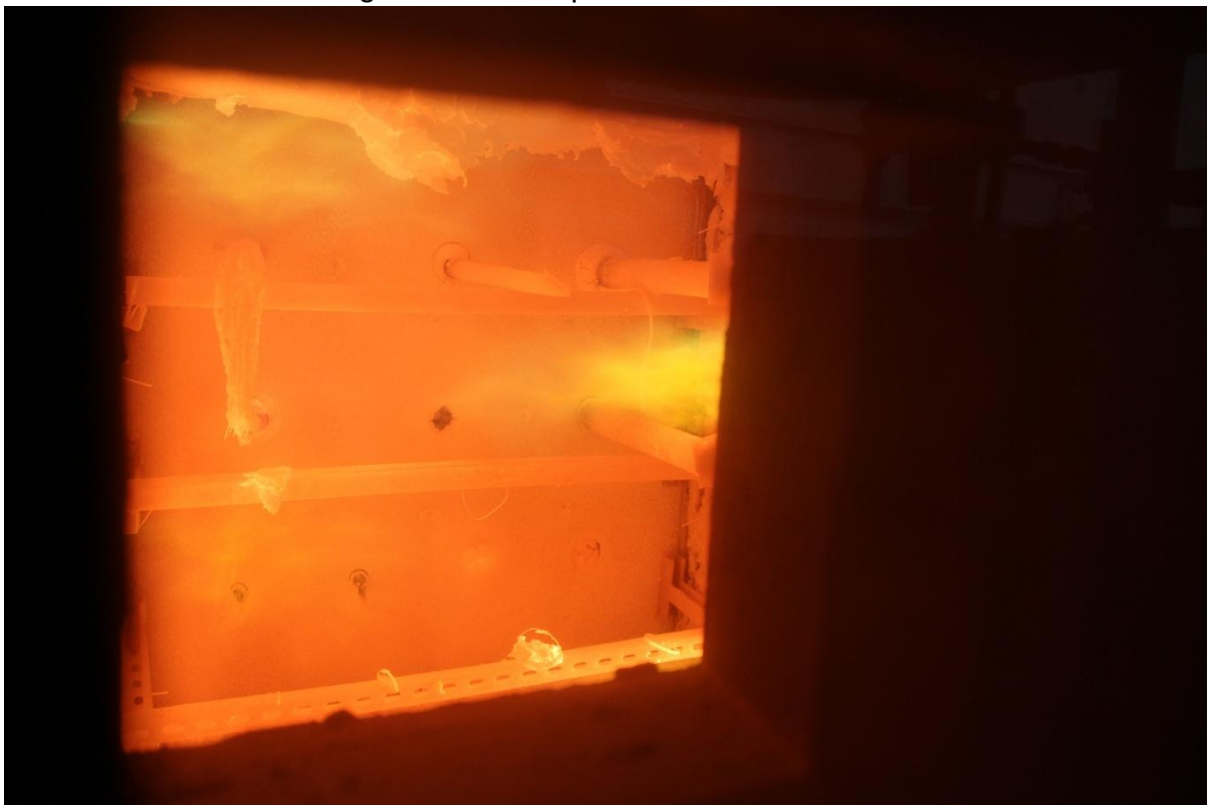
Figure 31 - Exposed face at 45 minutes

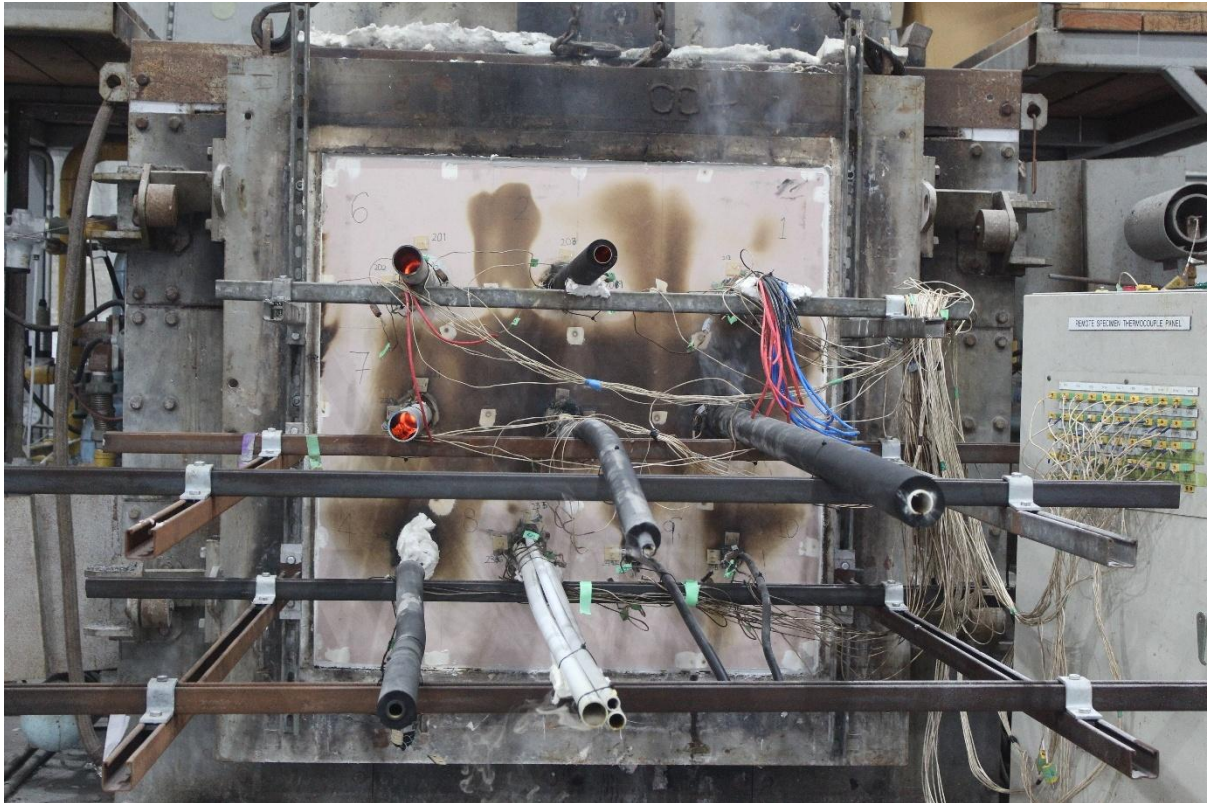
Figure 34 - Unexposed face at 90 minutes
