## **BOSS Products Pty Ltd**

### **Test Report 148693**

120 mm slab with MaxiCollar™

**AS 1530.4:2014**

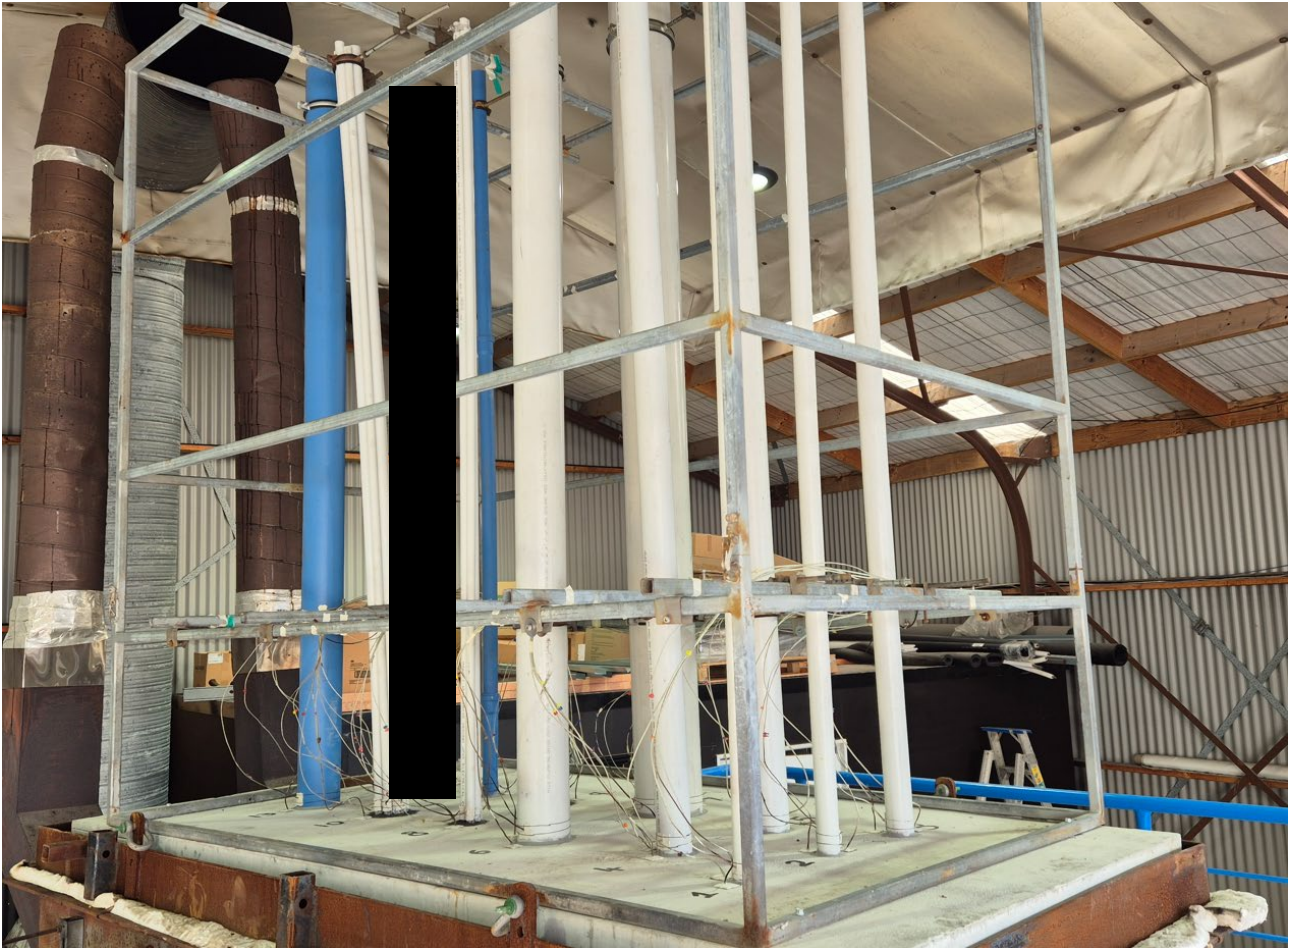
Appendix Figure C-1: Penetrations 1-13, unexposed side prior to test commencement.

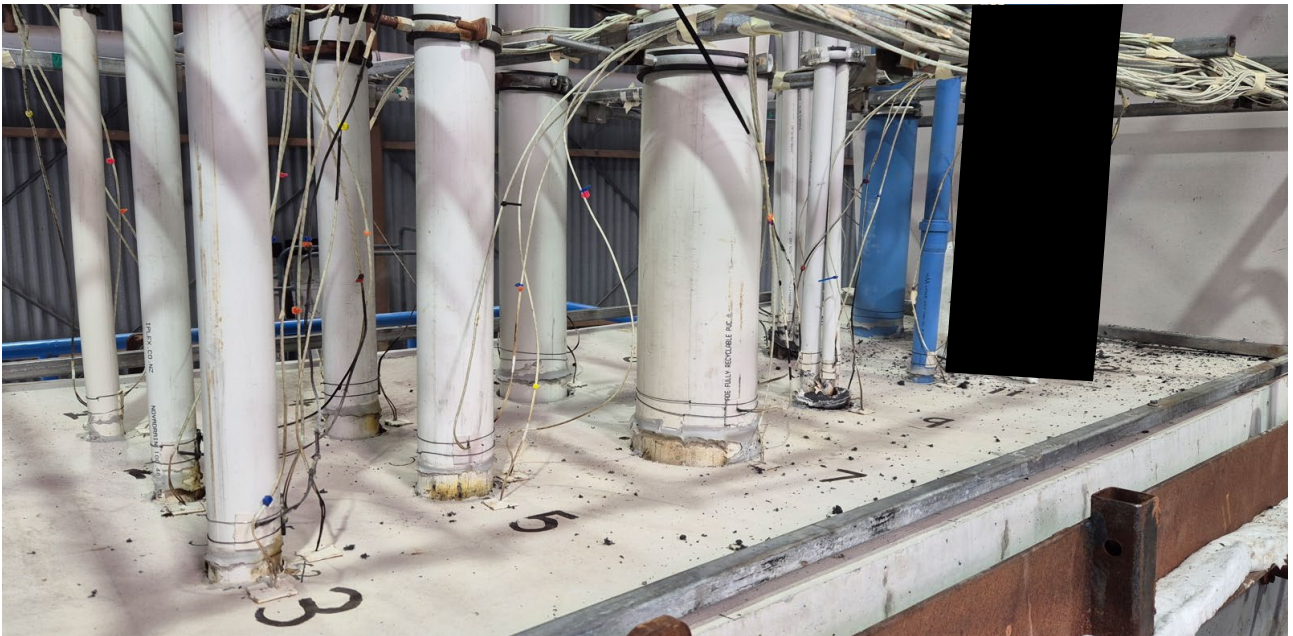
Appendix Figure C-8: Penetrations 1-13, unexposed side at 180 minutes.

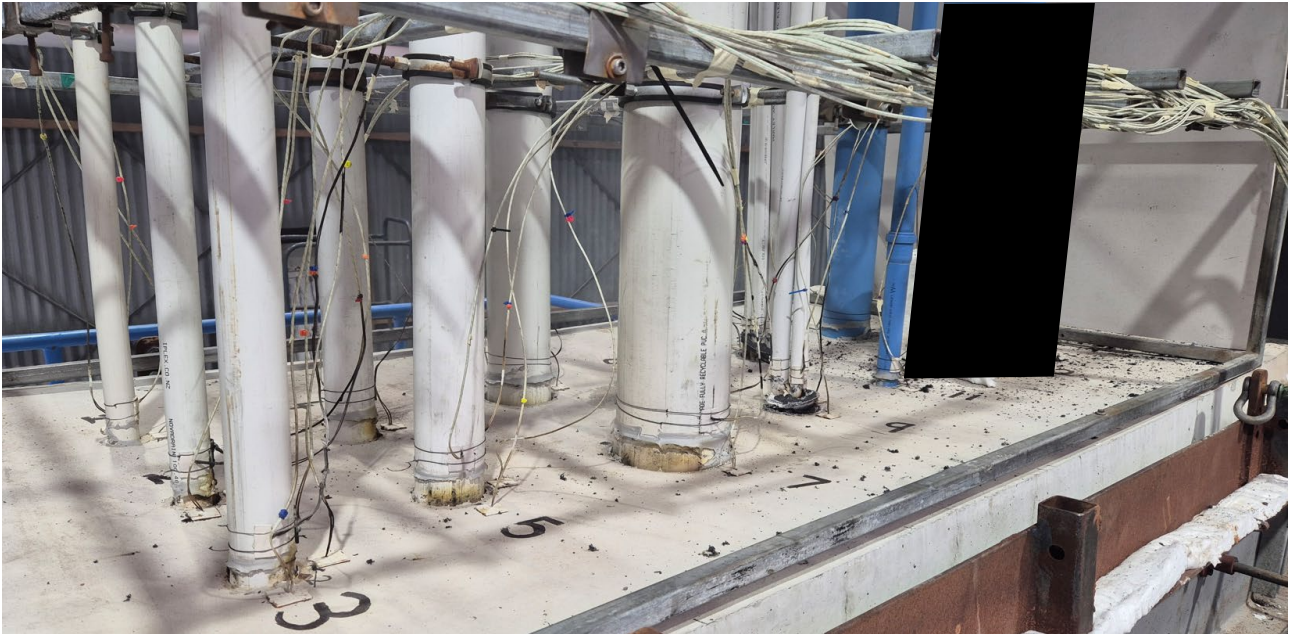
Appendix Figure C-9: Penetrations 1-13, unexposed side at 210 minutes.

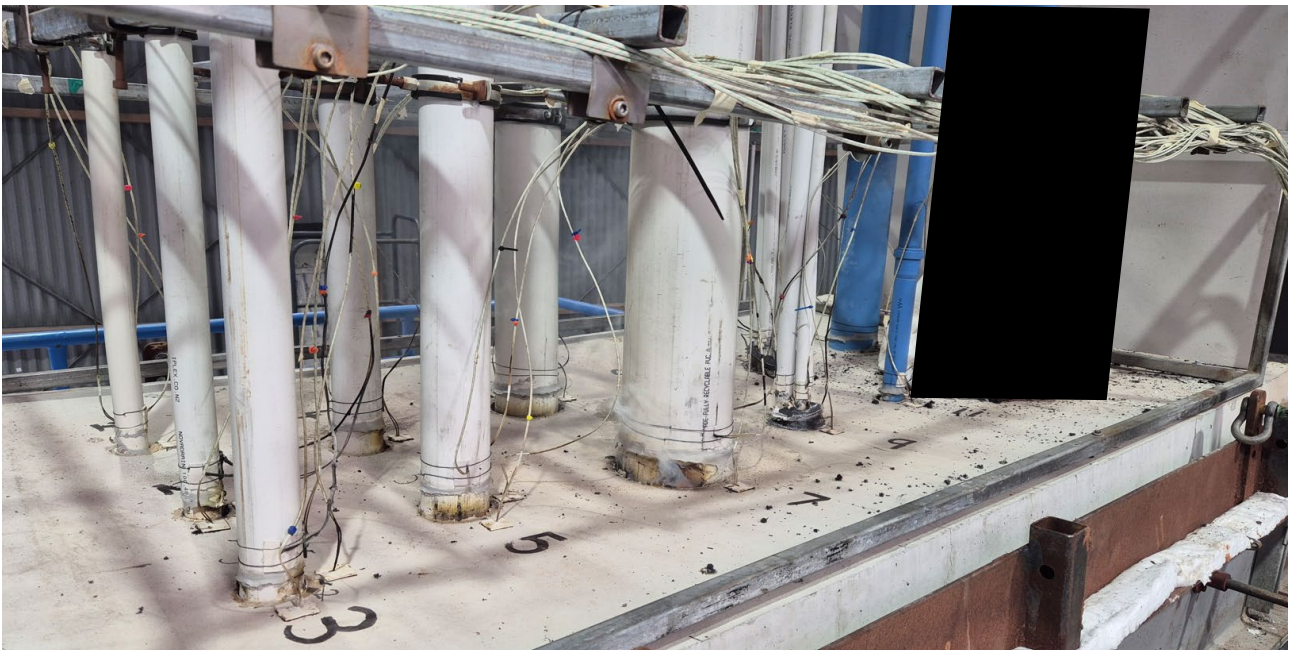
Appendix Figure C-10: Penetrations 1-13, unexposed side at 240 minutes.

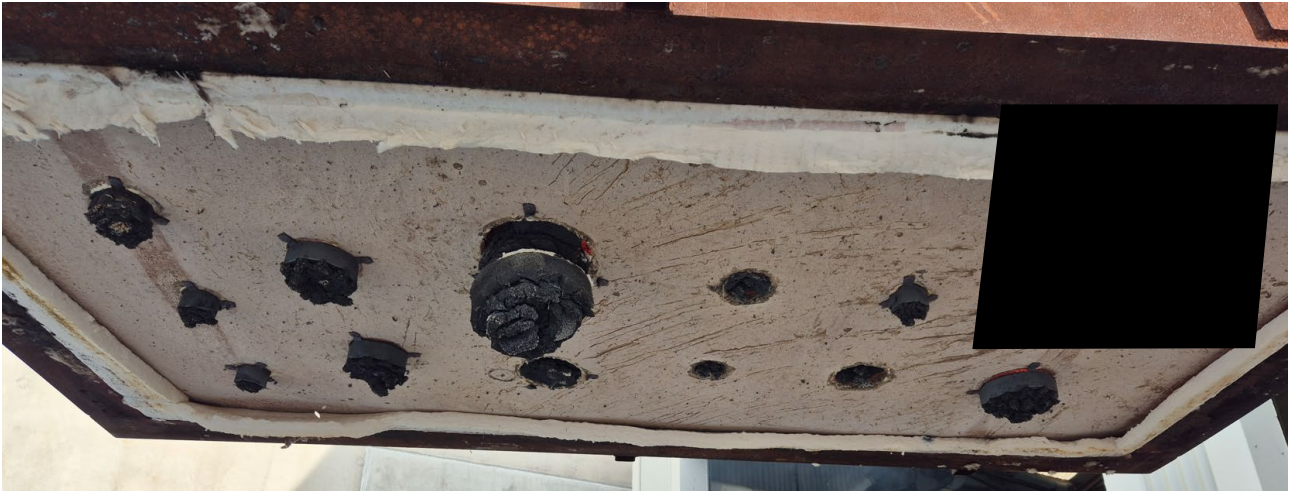
Appendix Figure C-11: Penetrations 1-13, exposed side at end of test.

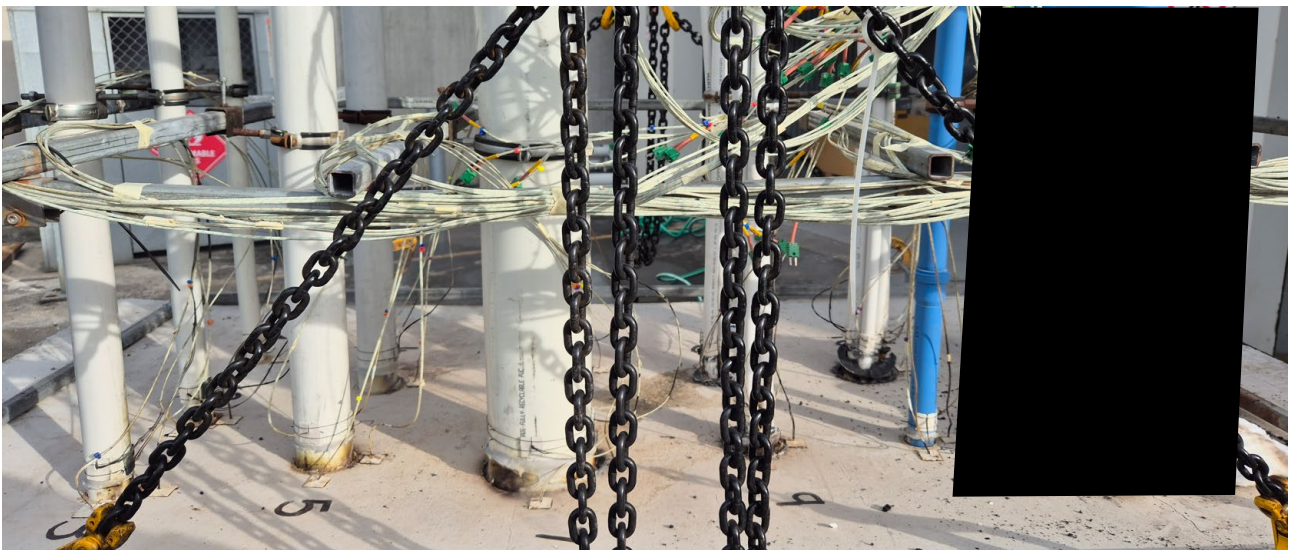
Appendix Figure C-12: Penetrations 1-13, unexposed side at end of test.
